Gulf States Marine Fisheries Commission
Special Report No. 2-WB

TWO METHODS OF MONITORING AND ASSESSMENT
OF ARTIFICIAL REEF MATERIALS

July 1989

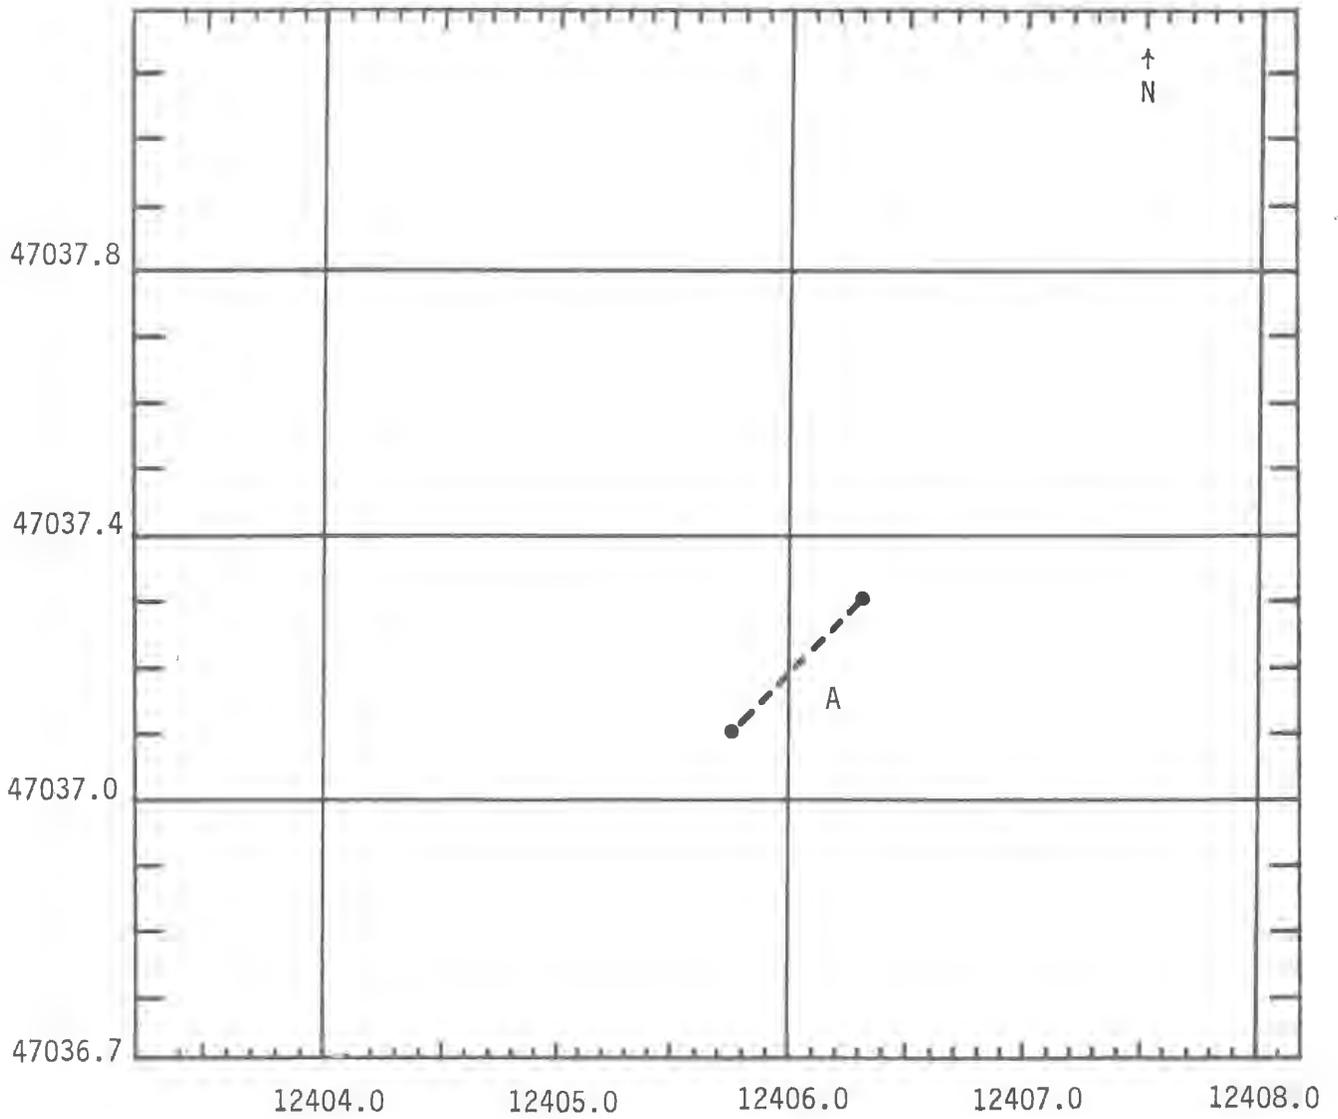
FH-1: Two separate targets within the FH-1 site were surveyed. The first target, designated Barge A, lies in approximately 70 feet of water (Figure 2). Table 2 provides measurements of the four corners of the barge indicating elevation above bottom. Minimum clearance above Barge A is approximately 58 feet. Barge A is a deck barge measuring 175' long, 73' wide, and 12' high and lies upright on the bottom. There is very little deterioration of the barge, limited to oxidation, and minimal scouring around the outer edge. The stern of the barge orients towards the northeast at approximately 45°.

Figure 2. Target A is a barge at site FH-1, plotted using data from the SCUBA survey method.

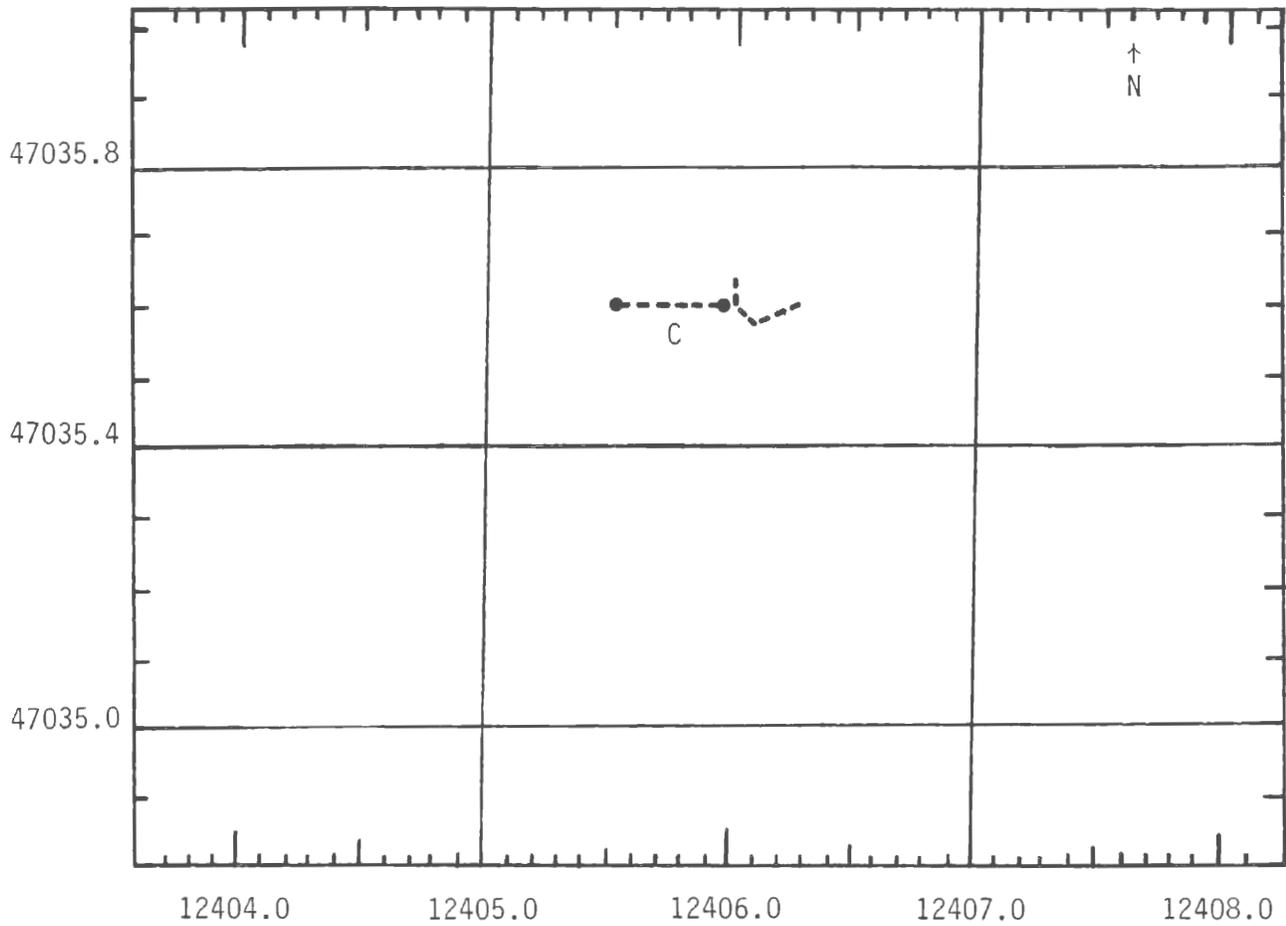
Due to high sea conditions target Barge B on FH-1 was not surveyed using SCUBA. The second target is designated as Barge C and also lies in approximately 70 feet of water (Figure 3). Measurements of the barge (Table 2) indicate a minimum clearance above the structure of 62 feet. Barge C is a hopper barge which lies upside down and measures 280' long, 50' wide, and 15' high. Deterioration is minimal. Large holes resulting from dynamite charges used to sink the barge are evident, with the most notable occurring on the north (starboard) side near the bow. The bow of the barge orients towards the east at approximately 95°. There is a scoured trench along the north side of the barge approximately 3' wide and 3' deep. Part of the rake end of the bow is buried in the bottom.

the north end of the barge bow. It lies upside down and slightly tilted towards the east in a scoured depression. The axis of the boxcar orients north and south and is almost perpendicular to Barge C. The other three boxcars lie approximately 70-100 feet east of the barge bow. All three boxcars are adjacent and upright. The concrete rubble is concentrated in the vicinity of the three adjacent boxcars. All boxcars show minimal deterioration and scouring.

Figure 3. Target C is a barge at site FH-1, plotted using data from the SCUBA survey method. Materials to the right of the barge are three railroad box cars.

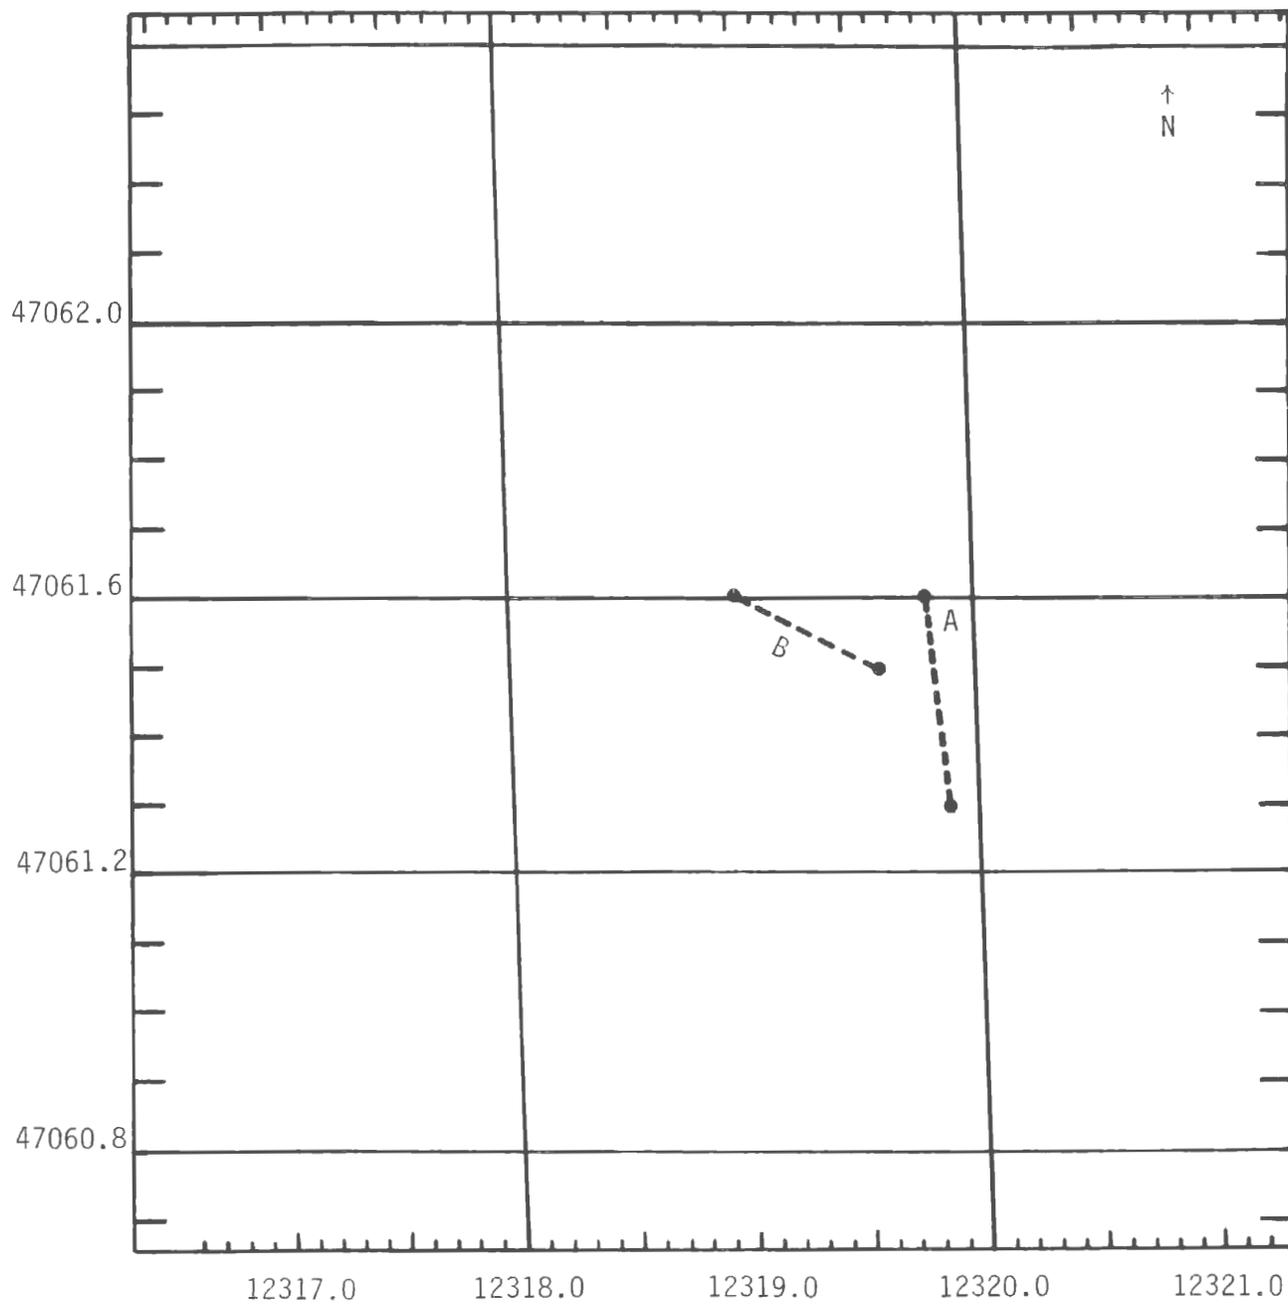
The second target, designated B, lies 150 to 200 feet west of target A in approximately 45 feet of water. Measurements (Table 2) indicate a minimum clearance of approximately 32 feet above the ship hull. The bow of hull A orients towards the north at approximately 352°. The stern of hull B orients towards the west-northwest at approximately 290°. Each hull measures approximately 476' long, 56' wide, and 15' high. There is minimal scouring around the hulls and it is confined to the ends of each hull. There has been some deterioration on each hull. Besides "flaking", cracks proceeding from the port side, down along the hull bottom, and up the starboard side at midship have been noted on both hulls. These are probably a result of the original construction design (each ship was built in halves and the halves welded together) and the sinking process (the stern section of each ship was flooded and came to rest on the bottom first; observers noted loud "pops" as each hull sank). The firebrick boilers in the engine rooms of both hulls have collapsed as have some bulkheads.

Several baled tire units originally attached in the ship hulls prior to sinking have deteriorated or altogether disappeared. Individual tires are scattered within the hulls and occur mainly between the bases of the ship's gussets (ribs). Several shrimp trawls have become entangled on both ship hulls.

Figure 4. Targets A and B are Liberty ship hulls at site FH-3, plotted using data from the SCUBA survey method.

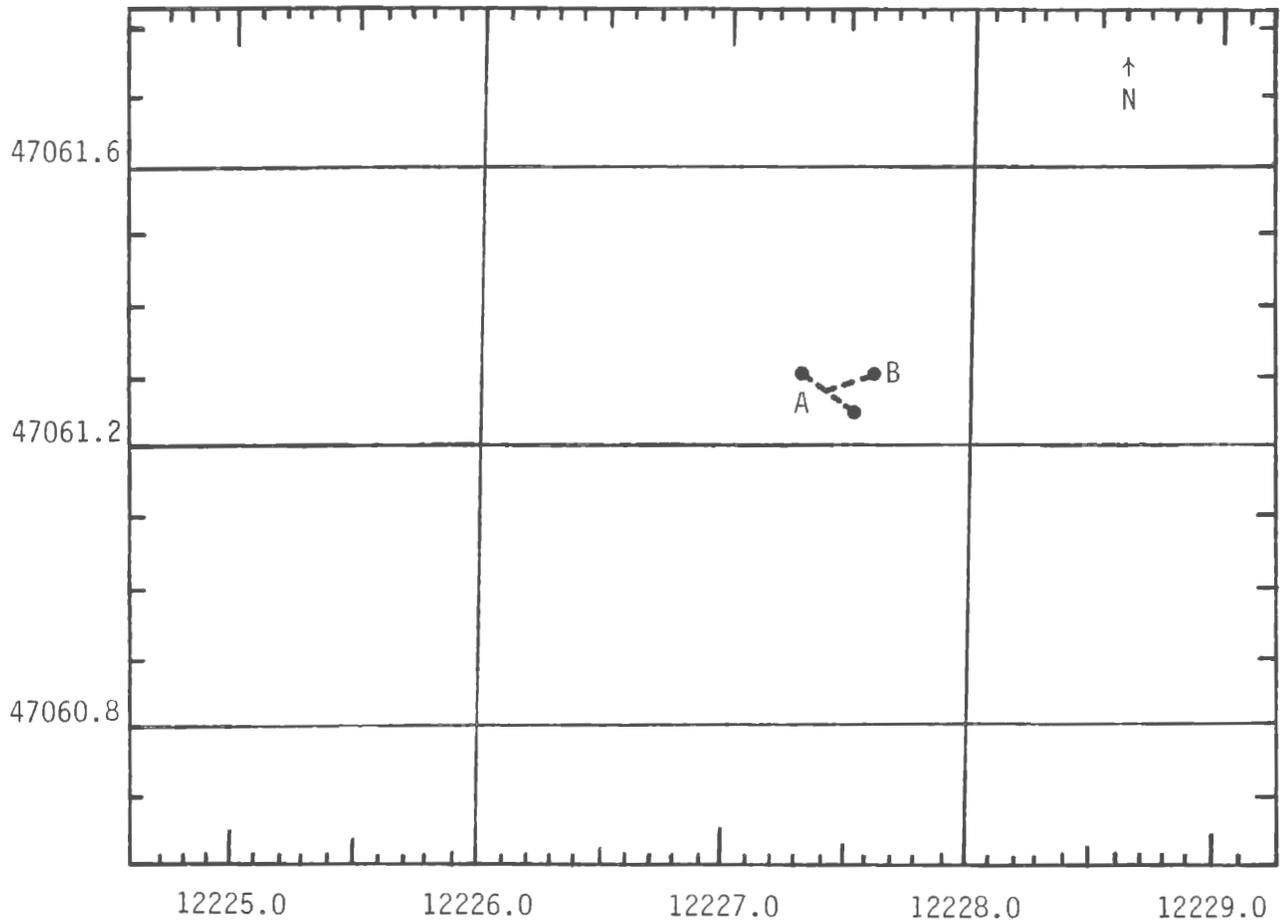
There has been minimal deterioration ("flaking") of both barges and concrete materials. Damage from dynamite charges used on barge A are evident but were not noted on barge B. There is some trench scouring around the outer edges of A and B on the north side where they meet.

Figure 5. Targets A and B are barges at site FH-4, plotted using data from the SCUBA survey method.

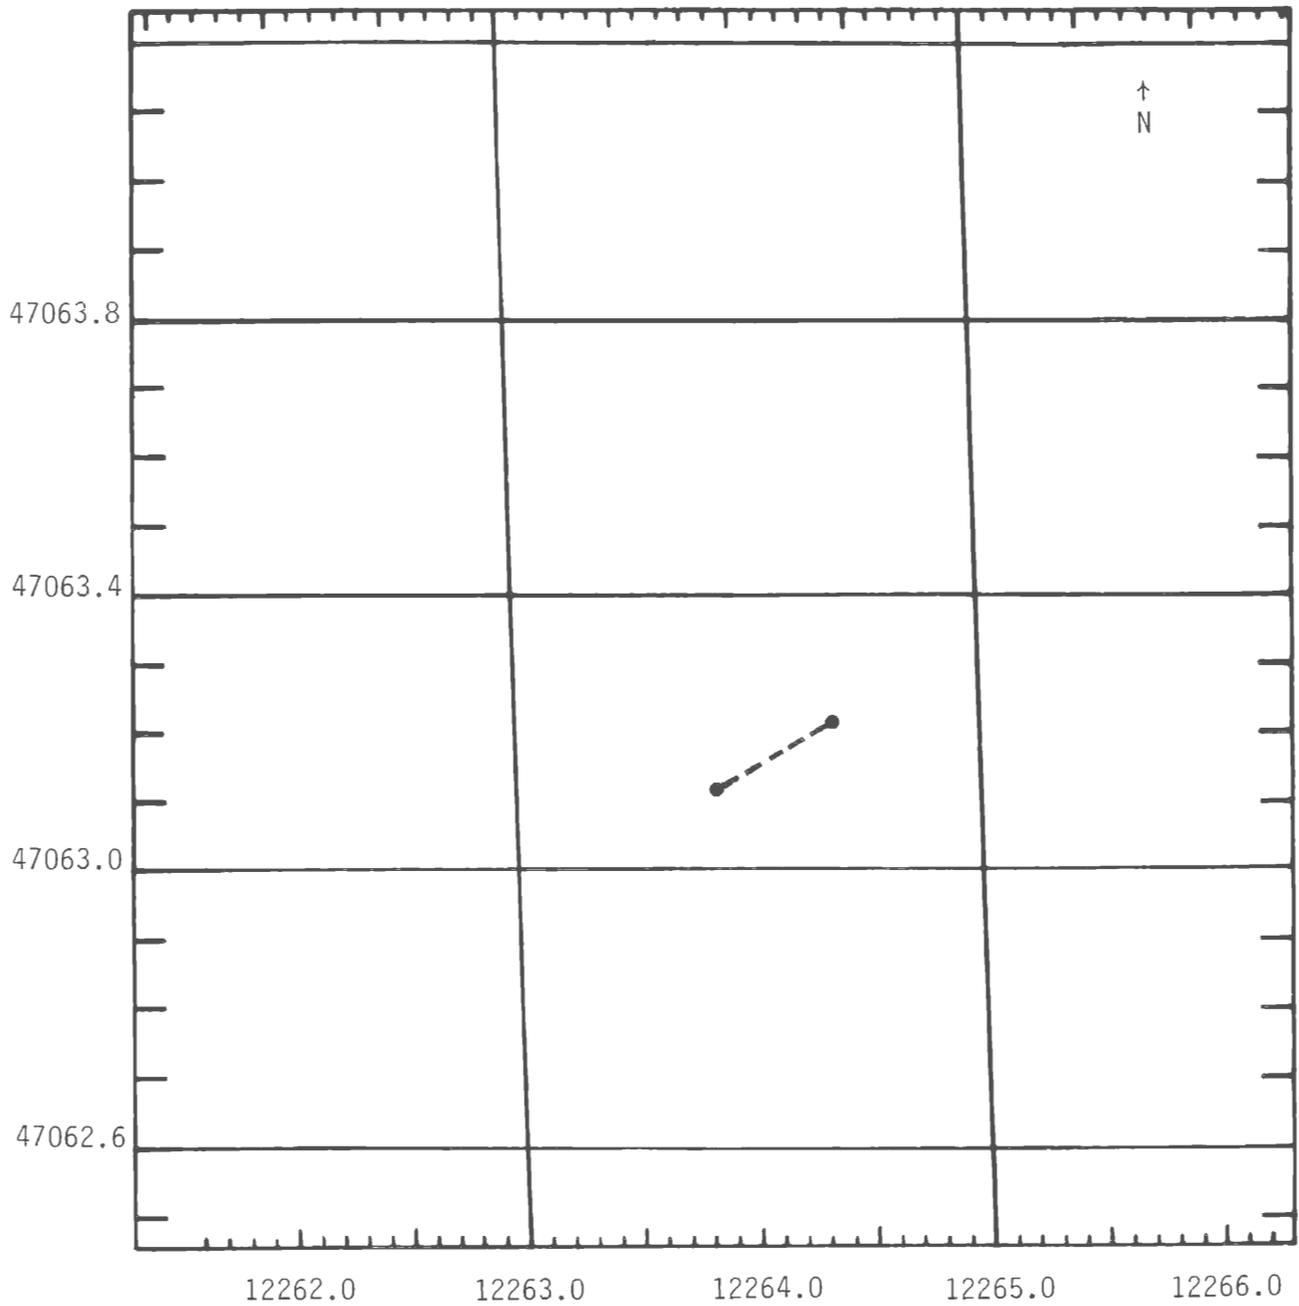
The barge at FH-5 measures 195' long, 35' wide, and 12' high and is a hopper barge. It contains several waste dumpsters located near the bow. The stern of the barge orients towards the northeast at approximately 45°. There is a large "blow hole" from the dynamite charge near the port bow. Several dumpsters have collapsed and have been partially buried by sediments entering through the "blow hole". A large scoured depression occurs at the bow (southwest) end of the barge and proceeds partially around the starboard side. Deterioration of the barge has been minimal.

Figure 6. Target is a barge at site FH-5, plotted using the SCUBA survey method.

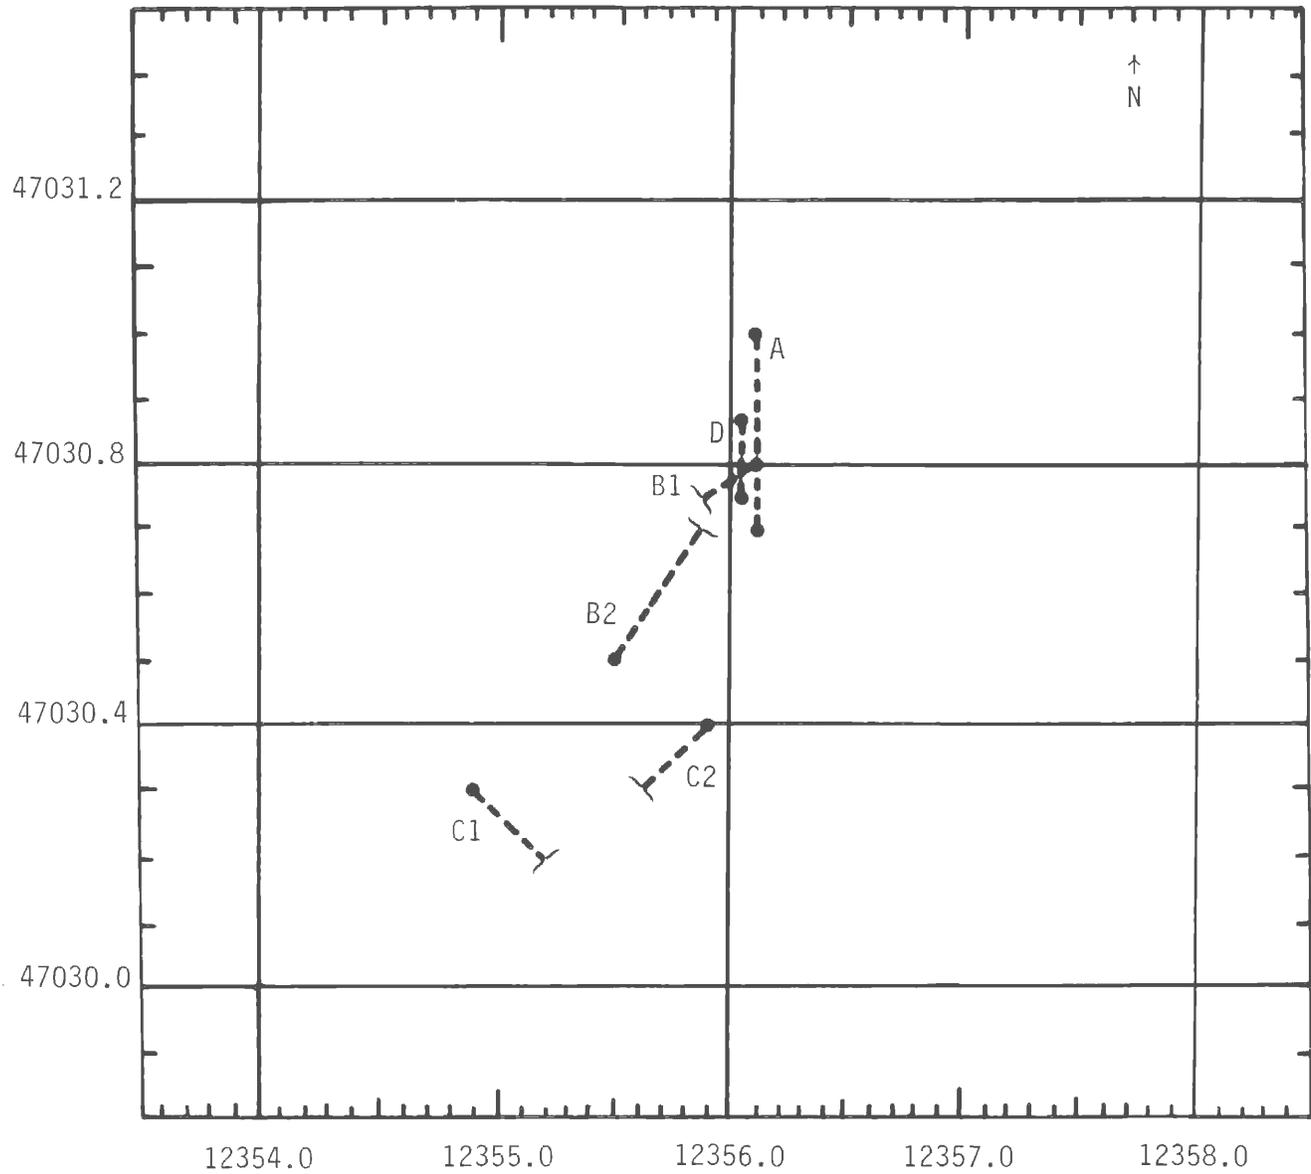
Target C is a Liberty ship originally measuring 476' long, 56' wide, and 15' high, which has broken in almost identical halves and separated, creating two distinct targets designated C1 and C2 (Figure 7). C1 is separated from C2 by approximately 200-250 feet. Both C targets lie in approximately 65 feet of water. Minimum clearance above C1 and C2 is approximately 50 feet as derived from measurements (Table 2).

C1 is the forward section with the bow orienting towards the east at approximately 90°. There has been minimal deterioration of materials. Scouring is minimal except at the "break" end where a medium sized hole exists which is approximately 60' wide, 20' long, and 5' deep. A narrow, scoured trench occurs along the northern side of C1.

C2 is the aft half with the stern orienting to the northwest at approximately 310°. There has been some deterioration of C2. Besides "flaking", the firebrick boilers have collapsed as has a bulkhead just forward of the firebrick boilers. A depression similar to the one at C1 occurs at the "break" end of C2. A similar trench along the northern edge occurs also. Several shrimp trawls have become entangled on the C2 hull.

Barge D is a hopper barge measuring 195' long, 35' wide, and 12' high. The bow of barge D orients to the north at approximately 360°, lying upright and resting alongside and partially on top of the western (starboard) edge of the A hull. The starboard stern of barge D rests on top of the intersection of the B1 stern and the A hull. The port half of barge D rests even with the bottom surrounding the hole which encompasses the A-B1 complex. There has been minimal deterioration of barge D. A large "blow hole" exists at the port bow.

Figure 7. Target A is an intact Liberty ship hull. Targets B1, B2, C1, and C2 are each halves of Liberty ship hulls, and Target D is a barge. All targets were plotted using the SCUBA survey method.

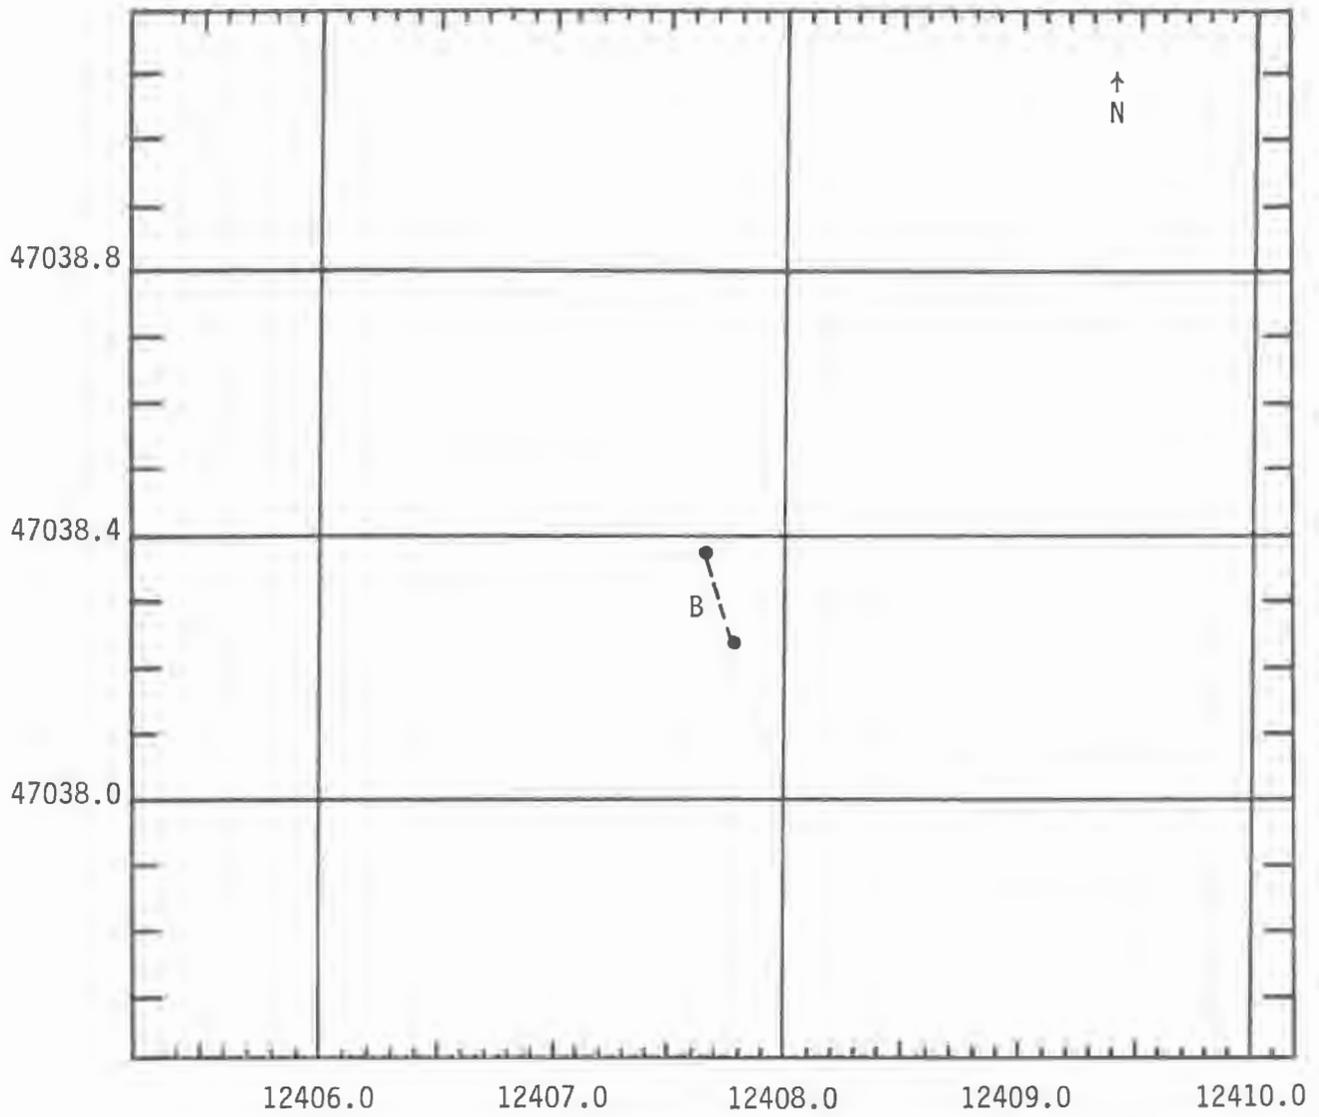
Average calculated length of target B (Figure 9), which was determined to be a barge, was 162 feet, while average measured width was 34 feet. Relief measurements were unsatisfactory due to unidentified obstructions near the target which created secondary returns from the shadow zone on the most favorable tracks. Six to 12 foot wide scour marks around the south end of target B suggests very little penetration into the bottom. A 10 to 12-foot wide shadow zone on top of the target suggests that the metal is deteriorating.

Figure 9. Target B is a barge at site FH-1, plotted using data from the side scan sonar survey method.

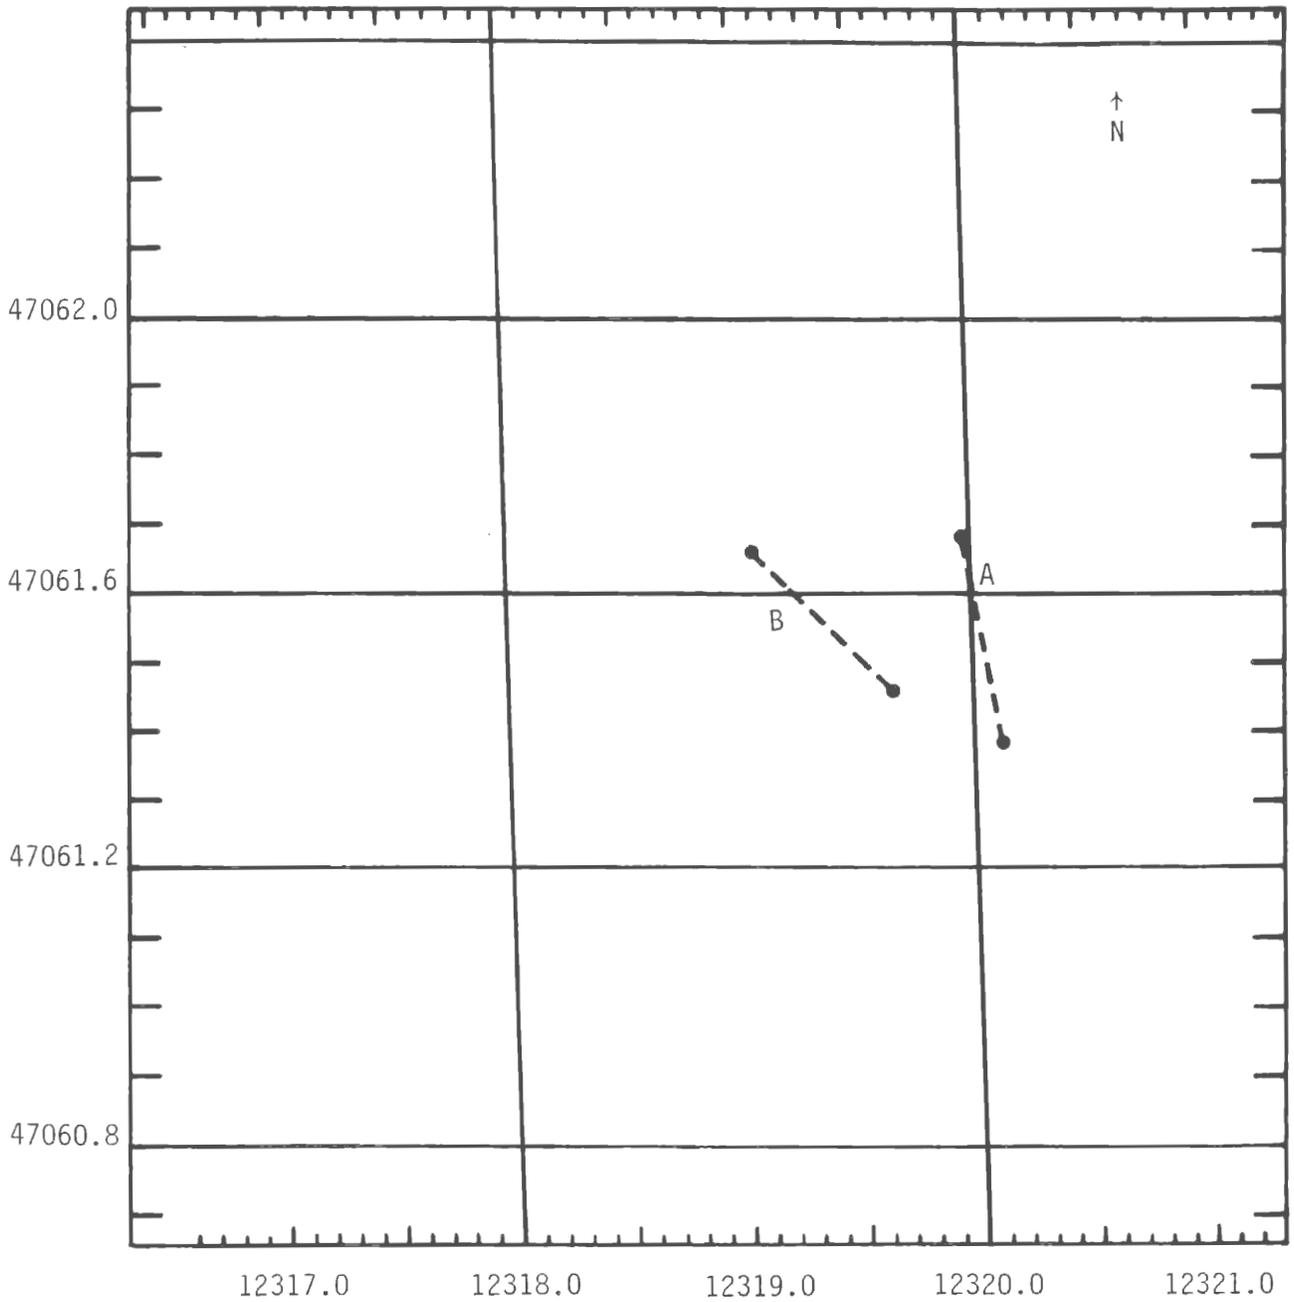
FH-3: FH-3 contains two scrapped Liberty ship hulls which each appear to be over 400 feet in length (Figure 12). Precise measurement of ship hull lengths was not possible due to an under-estimate of the survey vessel speed. This distortion was noted when survey tracks parallel to the target ship hull's orientation were compared. Ships' widths averaged 60 feet, while their heights were poorly defined, appearing to be greater than 10 feet. The two hulls appear to be about 200 feet apart at the closest point (Figure 13).

Figure 12. Targets A and B are Liberty ship hulls, plotted using data from the side scan sonar survey method.

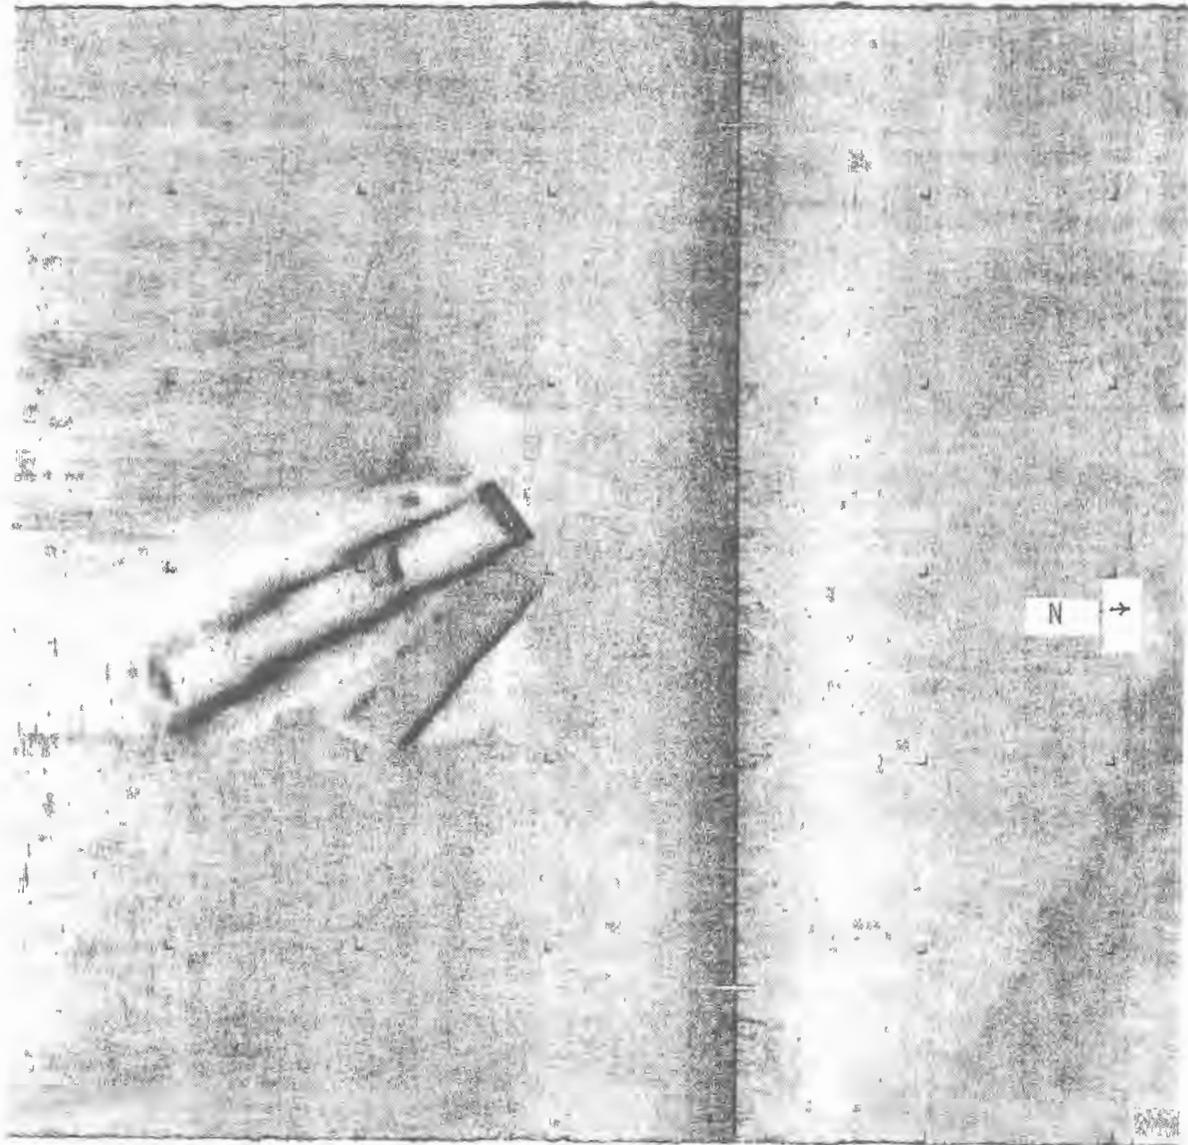
Figure 15. Two barges from side scan sonar record at FH-4. Scouring is indicated by light areas to the right of the smaller barge and above the larger barge. Scale along-track is 10 m/cm and across-track is 10.7 m/cm.

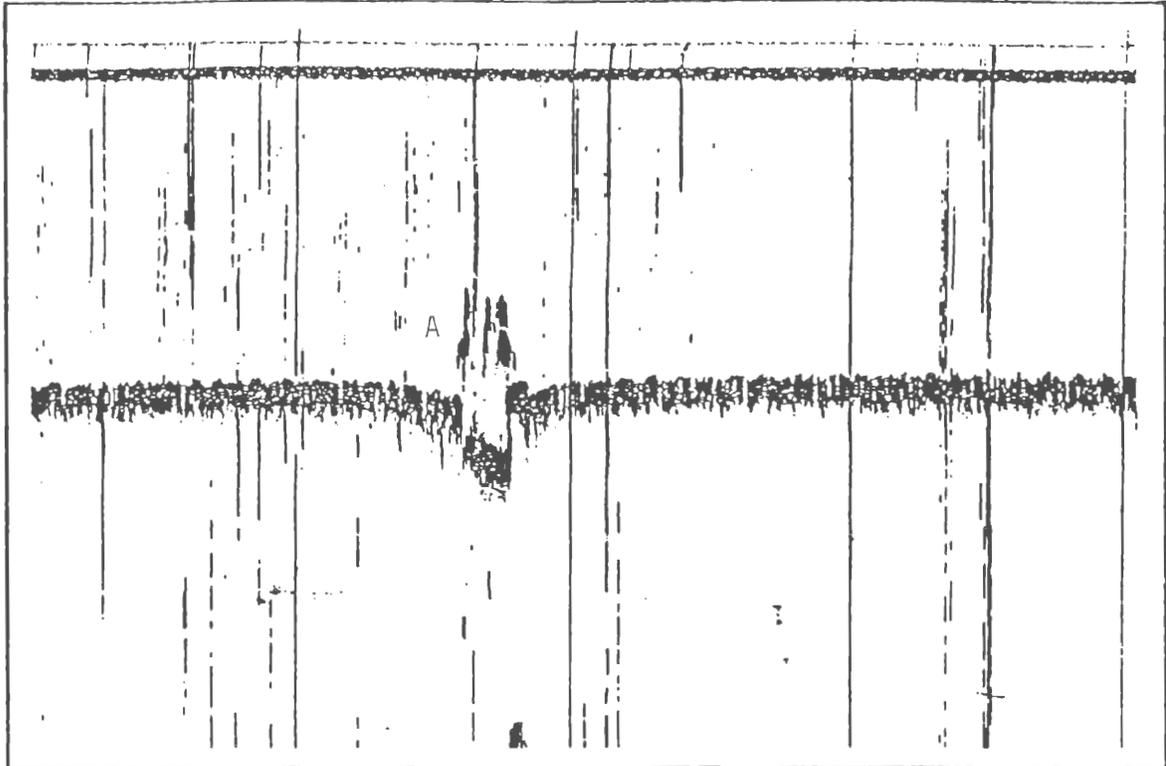
Figure 16. A depth recorder profile of Target A (barge) at FH-4. According to this profile one to two feet of scouring has occurred along both sides of the barge. The barge appears to have settled about five feet into the substrate.

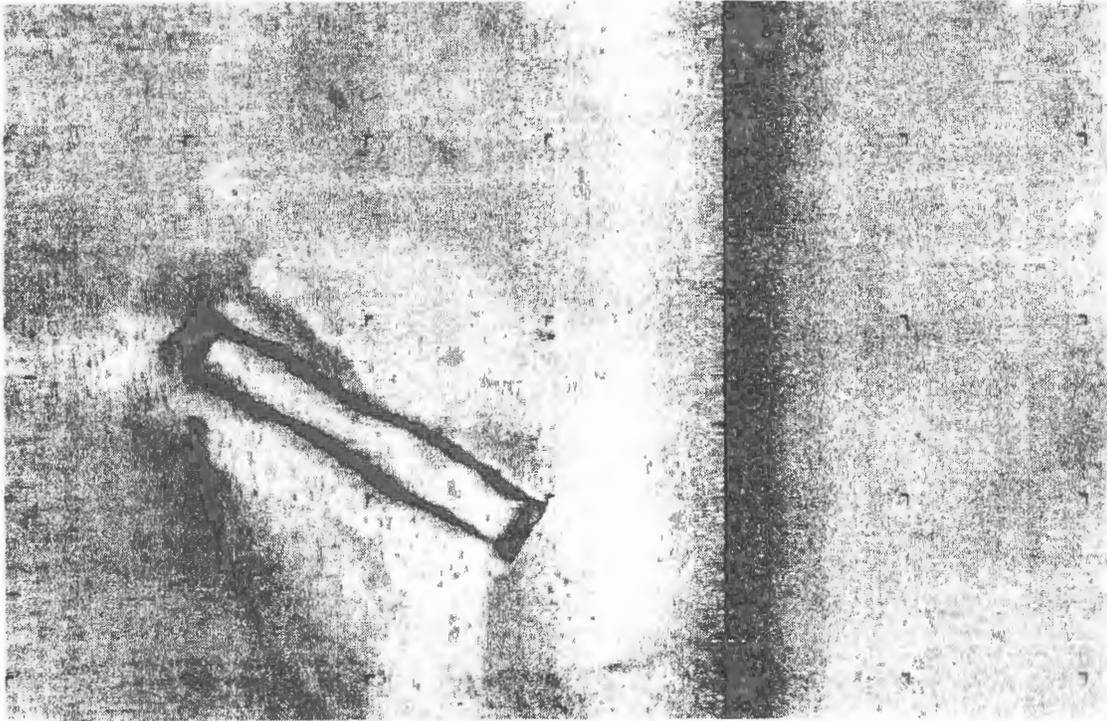
Figure 18. Barge from side scan sonar record at FH-5. The large white areas above and to the right of the barge indicate scouring and possibly some settling into the substrate.

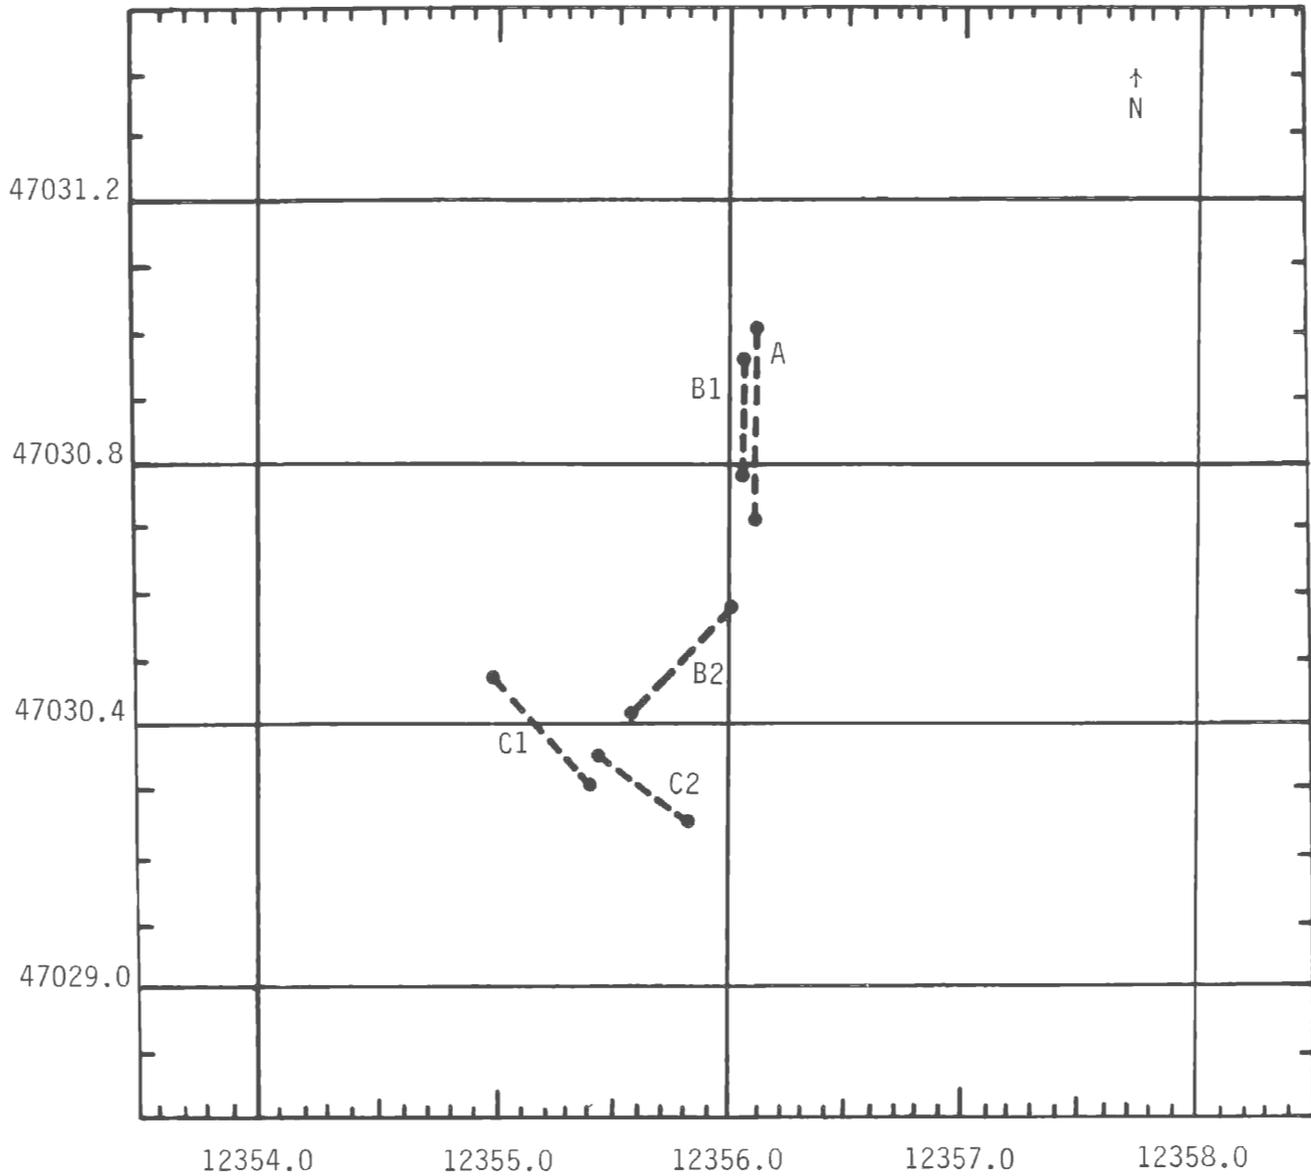
FH-6: FH-6 is composed of three ship hulls, two of which are broken in half and separated (Figure 19). The disposition of hulls at FH-6 is shown in Figure 20 with one of the broken hulls resting alongside the intact hull. The intact hull (Target A) is about 470 feet long, 65 feet wide, and less than 10 feet high. A broken piece of hull (B1), about 260 feet long, lies alongside the intact hull. A third fragment (B2 in Figure 20) lies about 150 feet south of the "A" hull. C1 and C2, which are halves of a Liberty ship hull, are oriented NW/SE. It is not possible to distinguish bow from stern on these passes.

Figure 19. Target A is an intact Liberty ship hull. Target B1 is a barge which was misidentified as half of a Liberty ship hull. Targets B2, C1, and C2 are halves of Liberty ship hulls. All materials were plotted at site FH-6 using data from the side scan sonar survey method.

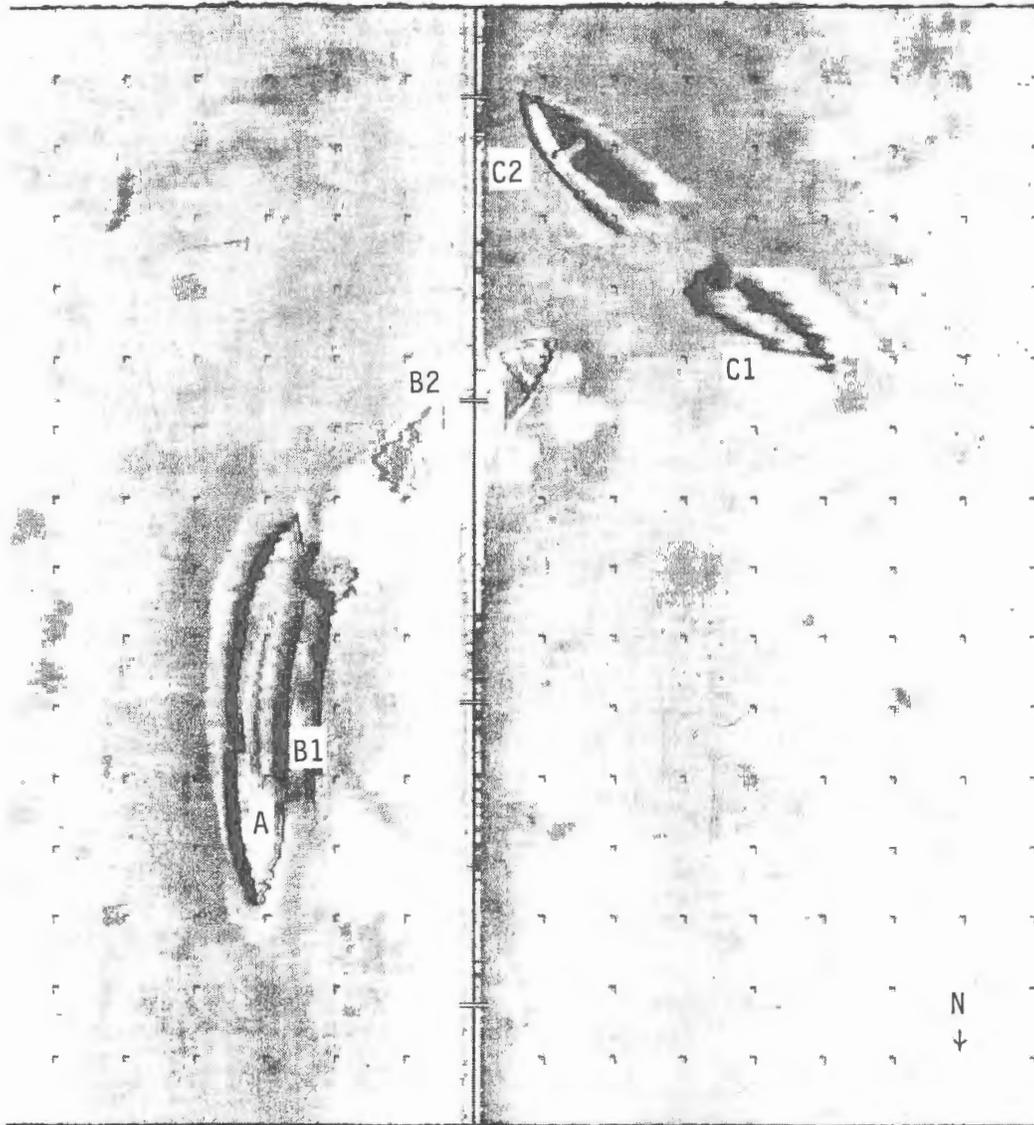
When using side scan sonar equipment in this application, one can assume that the identity of the targets to be surveyed would be known. It is important; however, to point out that in most cases when side scan sonar is being used to locate a target, confirmation of the identity of such targets is made using SCUBA divers. Referring to Figure 11, for example, it is difficult to ascertain that targets A and B are railroad boxcars and that target C is a hopper barge which is lying bottom side up. Figure 20 is an image of three ship hulls. High sea conditions

caused this image to deteriorate, thus it is difficult to determine the target identities; however, a clearer, more precise image would be much easier to analyze. Target B1 in Figure 20 is a barge lying alongside the ship hull (Target A). Identification of this target using side scan sonar alone would have been very difficult. Since SCUBA is a direct observation, in most cases with adequate water visibility identification of targets is precise.

Figure 20. Liberty ship hulls at site FH-6. Target A is an intact hull, while targets B1, B2, C1, and C2 are halves of two other hulls. Scale along-track is 21.3 m/cm and across-track is 12.6 m/cm.
