Gulf States Marine Fisheries Commission
Special Report No. 2-WB

TWO METHODS OF MONITORING AND ASSESSMENT
OF ARTIFICIAL REEF MATERIALS

July 1989

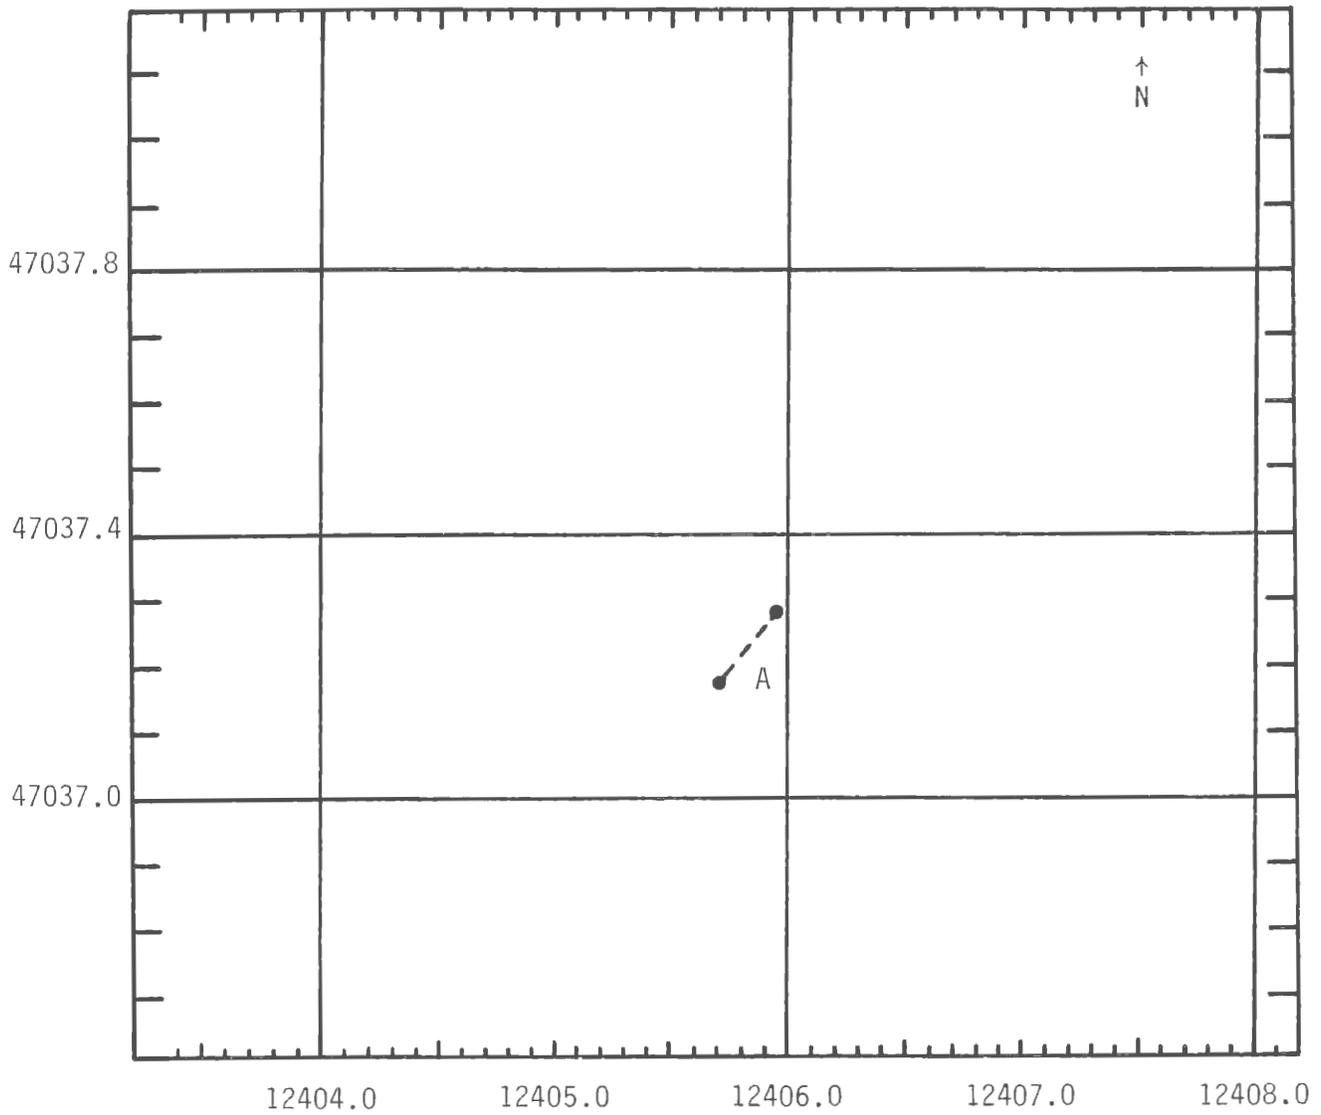
FH-1: FH-1 consists of three side scan targets. According to measurements derived from three side scan sonar passes, target A (Figure 8), which appears to be a barge, averages about 190 feet long, about 70 feet wide, and 10 feet high. Scour marks about 20 feet wide are detectable around the southeast and southwest corners of the target. These scour marks, plus the 10-foot measured relief (Table 2), suggest that target A is not settling into the bottom.

Figure 8. Target A is a barge at site FH-1, plotted using data from the side scan sonar survey method.

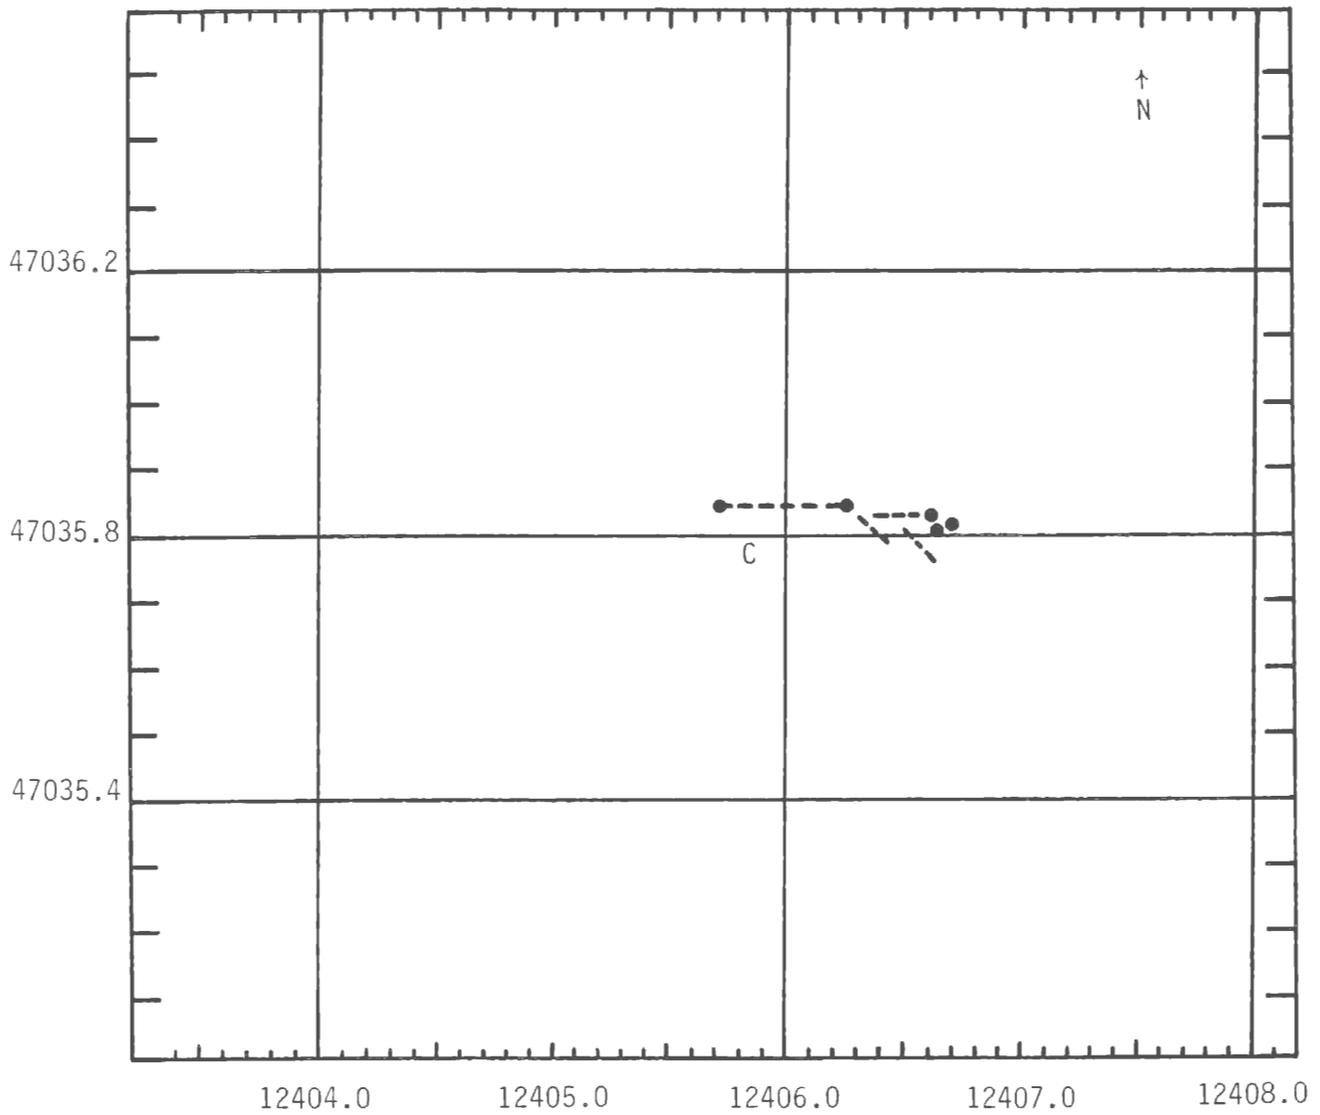
Target C (Figures 10 and 11) is a barge with some scattered materials to the east. On different passes, target C's measurement varied between 205 and 250 feet in length, 40 to 52 feet in width, and 4 to 8 feet in height. Three railroad boxcars, one measured as 50 feet in length, lie east and slightly north of the target. The closest boxcar is about 25 feet from target C. The target's measurement discrepancy is probably due to an inaccurate speed estimate.

Figure 10. Target C is a barge. Material to the right of Target C was unidentifiable from the side scan sonar record. All material were plotted using data from the side scan sonar survey method.

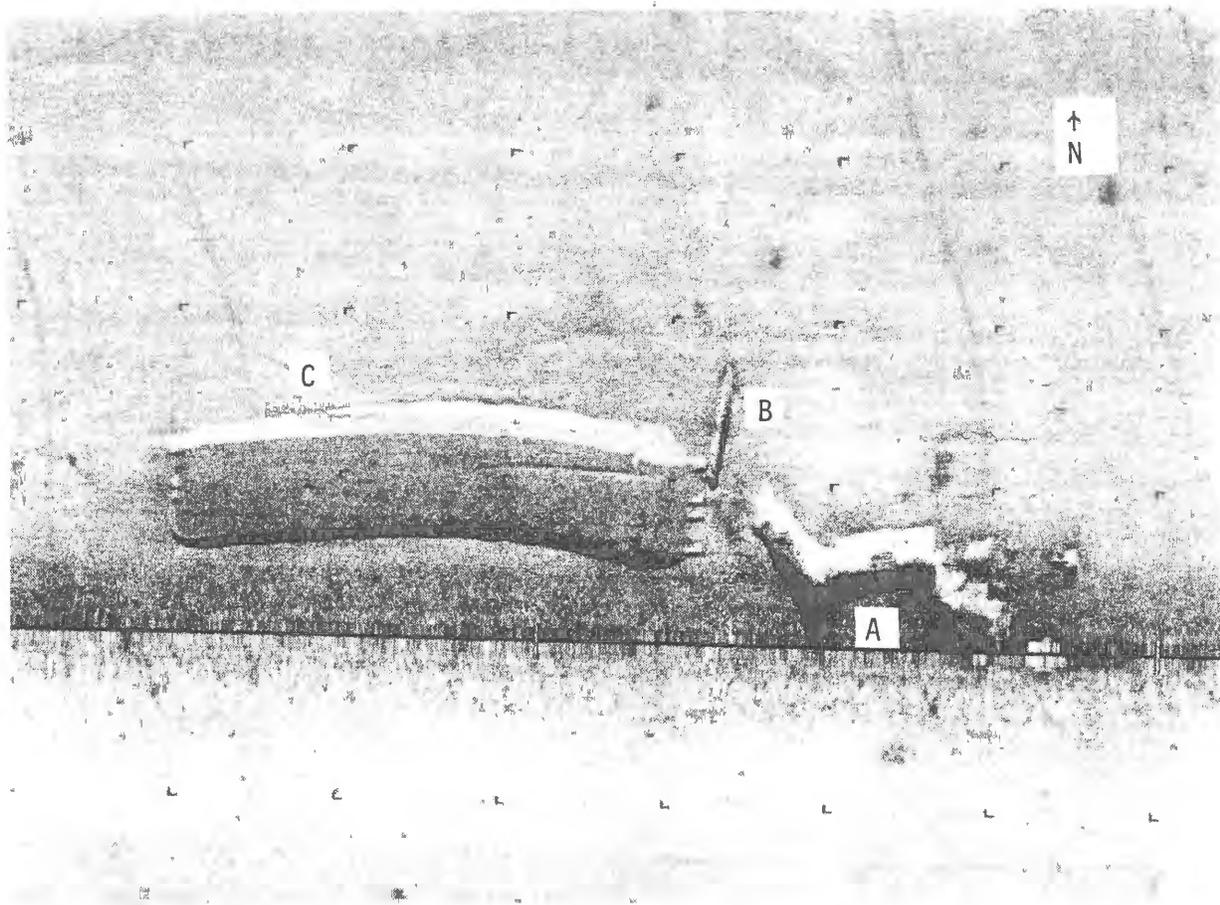
Figure 11. Reef target disposition using side scan sonar at site FH-1. Targets A and B are unknown, while Target C is a barge. Scale along-track is 10.7 m/cm. Scale across-track is 10 m/cm.

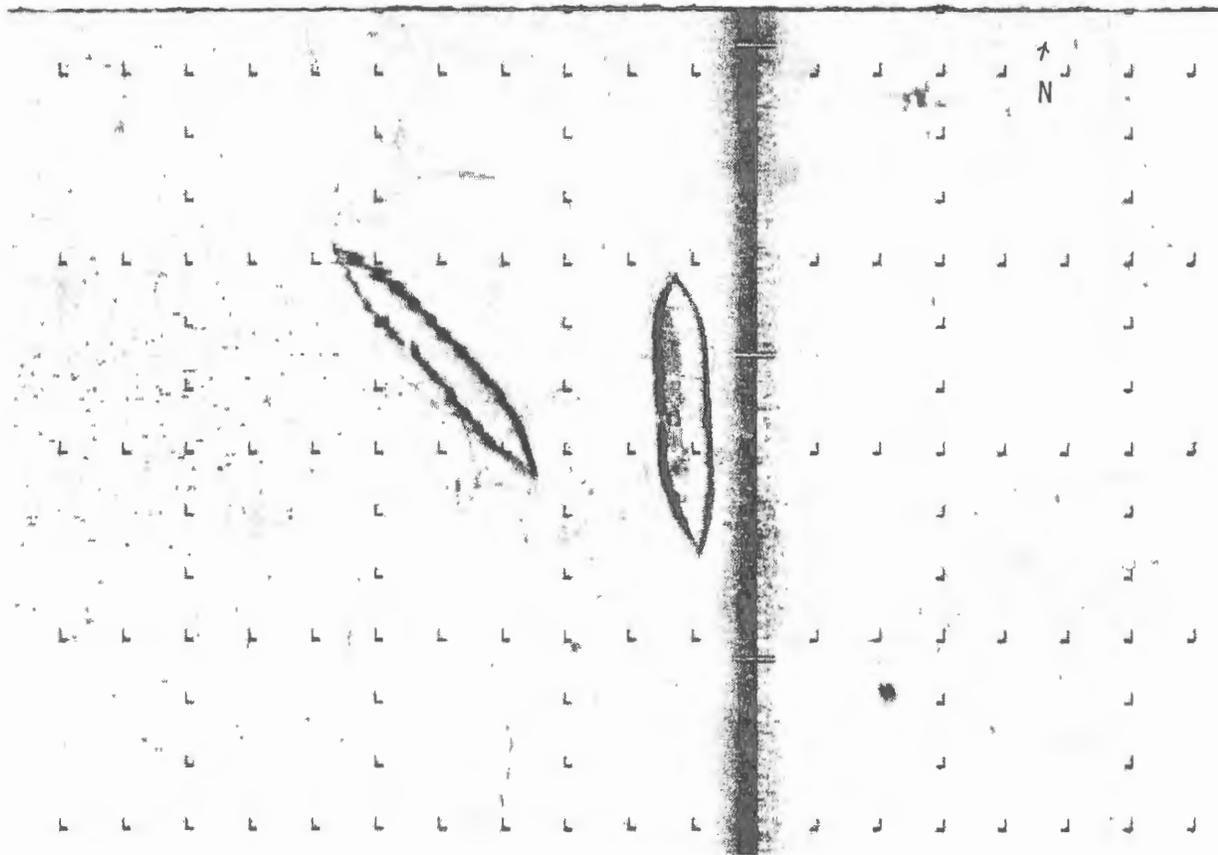
FH-3: FH-3 contains two scrapped Liberty ship hulls which each appear to be over 400 feet in length (Figure 12). Precise measurement of ship hull lengths was not possible due to an under-estimate of the survey vessel speed. This distortion was noted when survey tracks parallel to the target ship hull's orientation were compared. Ships' widths averaged 60 feet, while their heights were poorly defined, appearing to be greater than 10 feet. The two hulls appear to be about 200 feet apart at the closest point (Figure 13).

Figure 13. Liberty ship hulls from side scan sonar record at site FH-3.
Scale along-track is 32 m/cm and across-track is 30 m/cm.

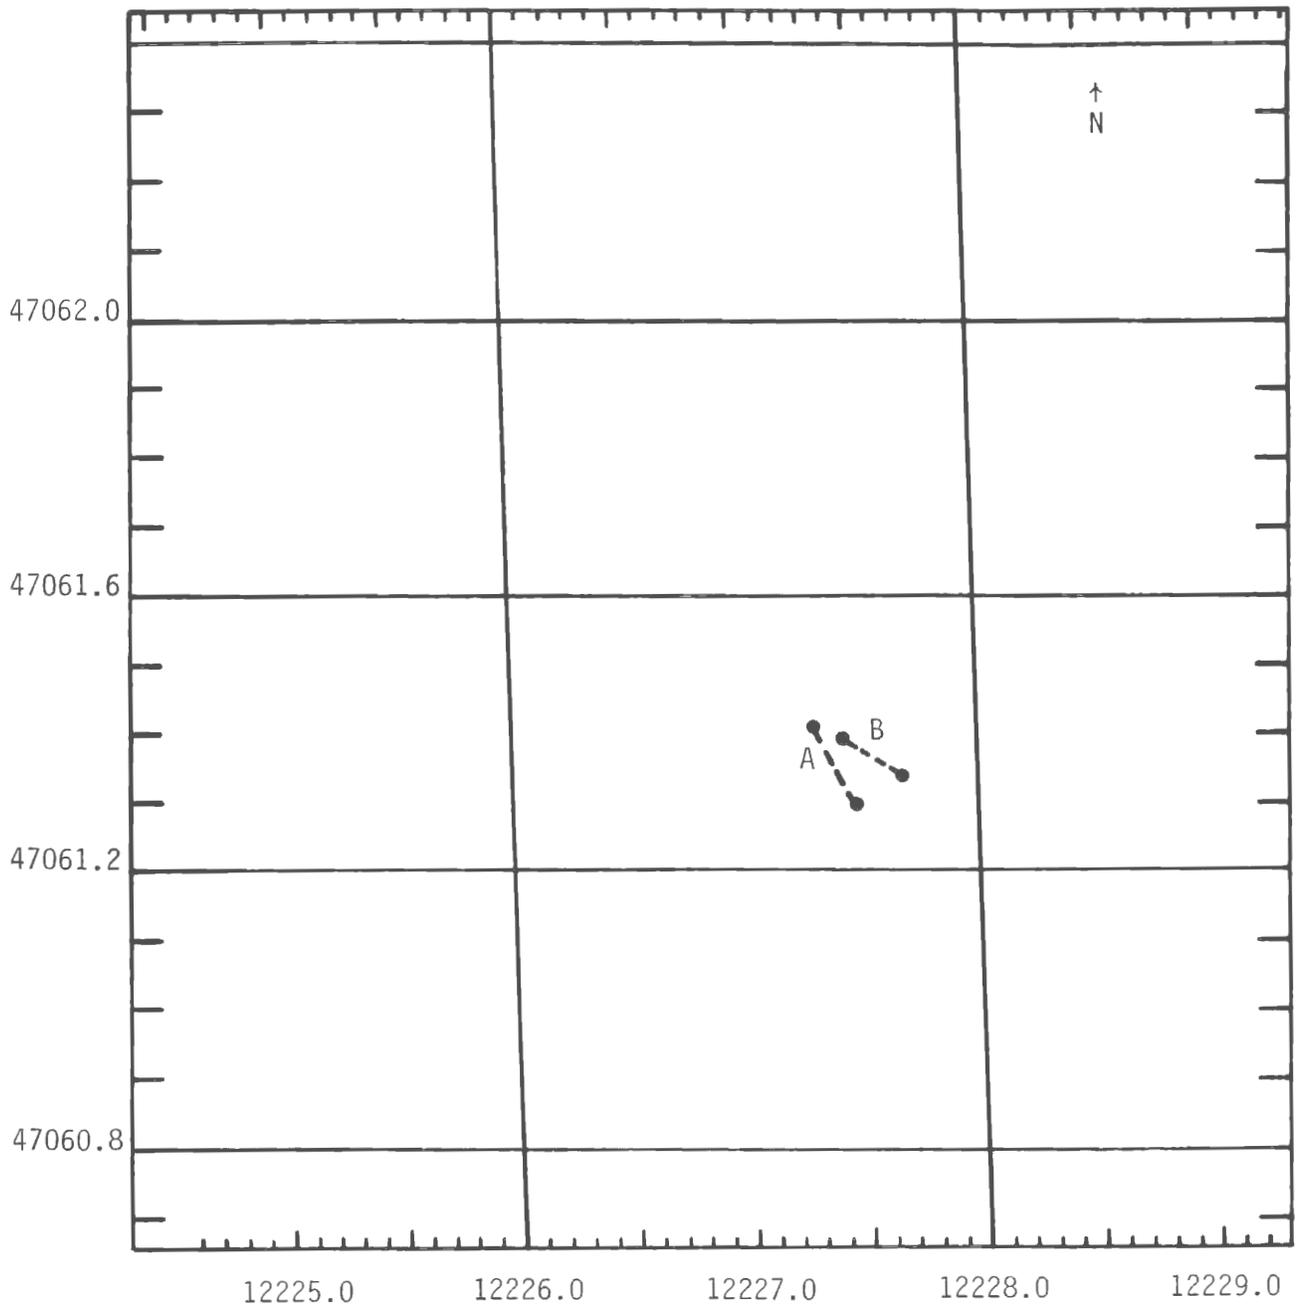
FH-4: Analysis of the survey tracks at FH-4 indicate two targets, both apparently barges (Figure 14). Target A (larger barge) had an

Figure 14. Targets A and B are barges at site FH-4, plotted using data from side scan sonar survey method.

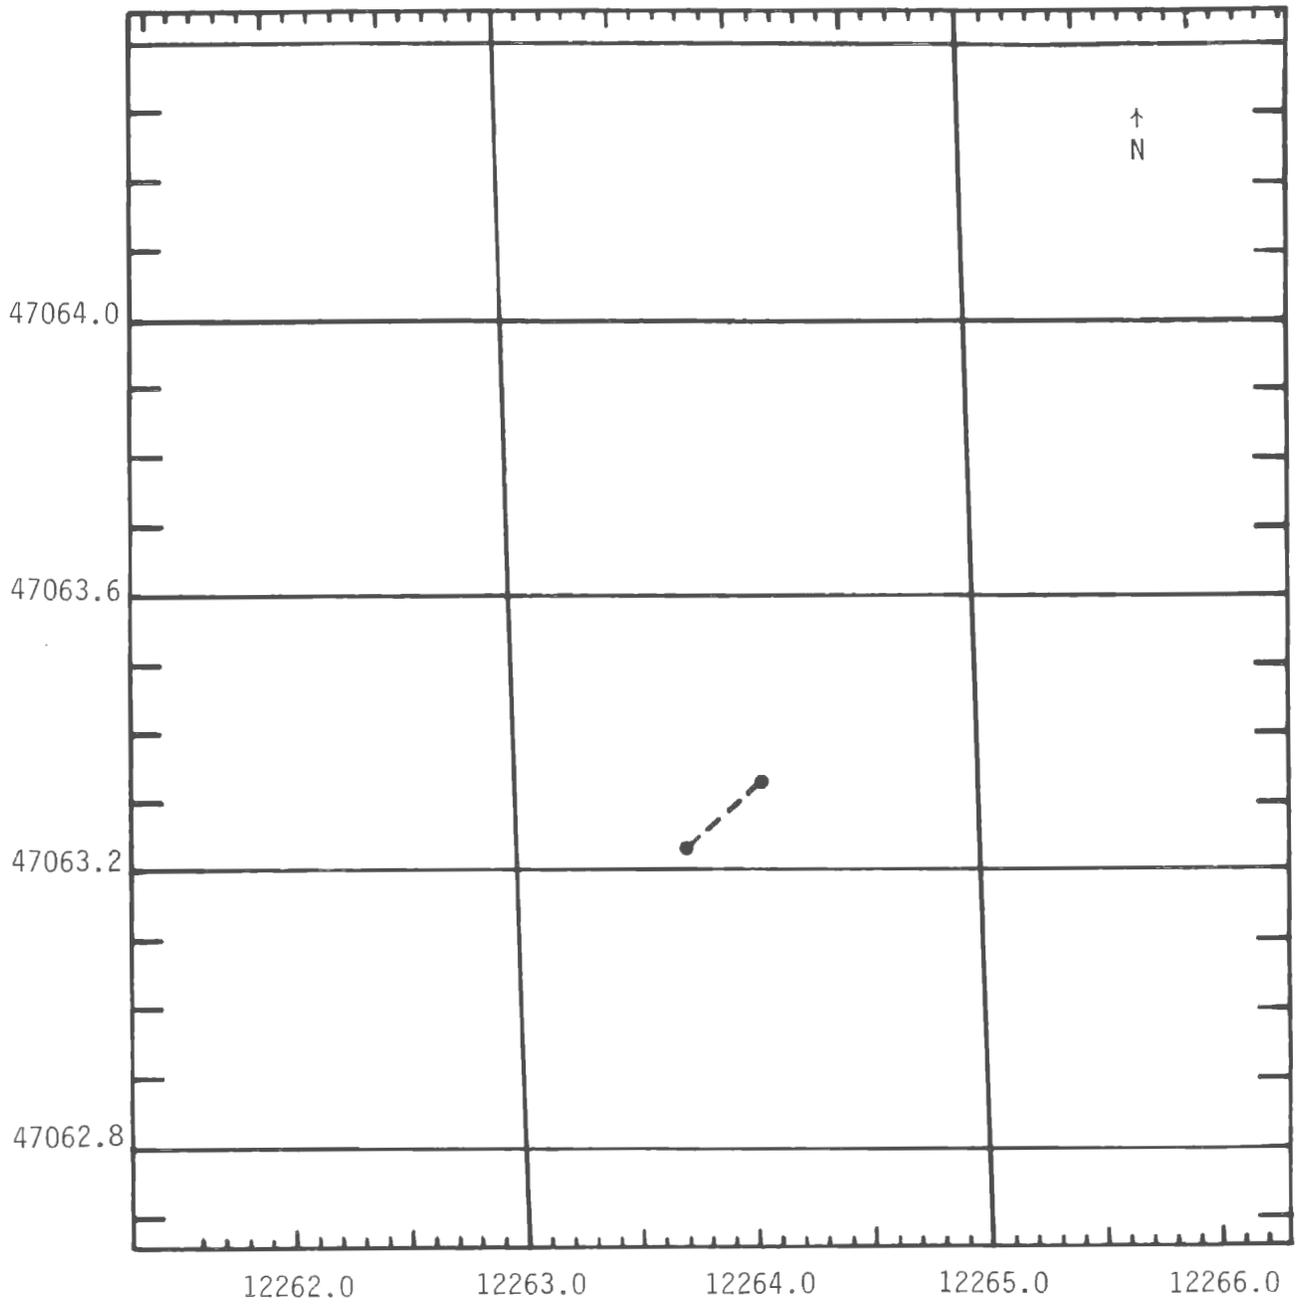
FH-5: The single target at FH-5 (Figures 17 and 18) is a barge. The average measured length and width is 190 feet and 34 feet, respectively. Barge height is estimated at no greater than 7 feet. Apparent scouring occurs in a 10 to 12-foot wide band around the southwest side of the barge (Figure 18).

Figure 17. Target is a barge at site FH-5, plotted using data from the side scan sonar survey method.
